## Fillmore Street Bridge Improvements and Trail Connections - I-25 to Monument Creek Project

# ▶ EXISTING CONDITIONS: BRIDGES

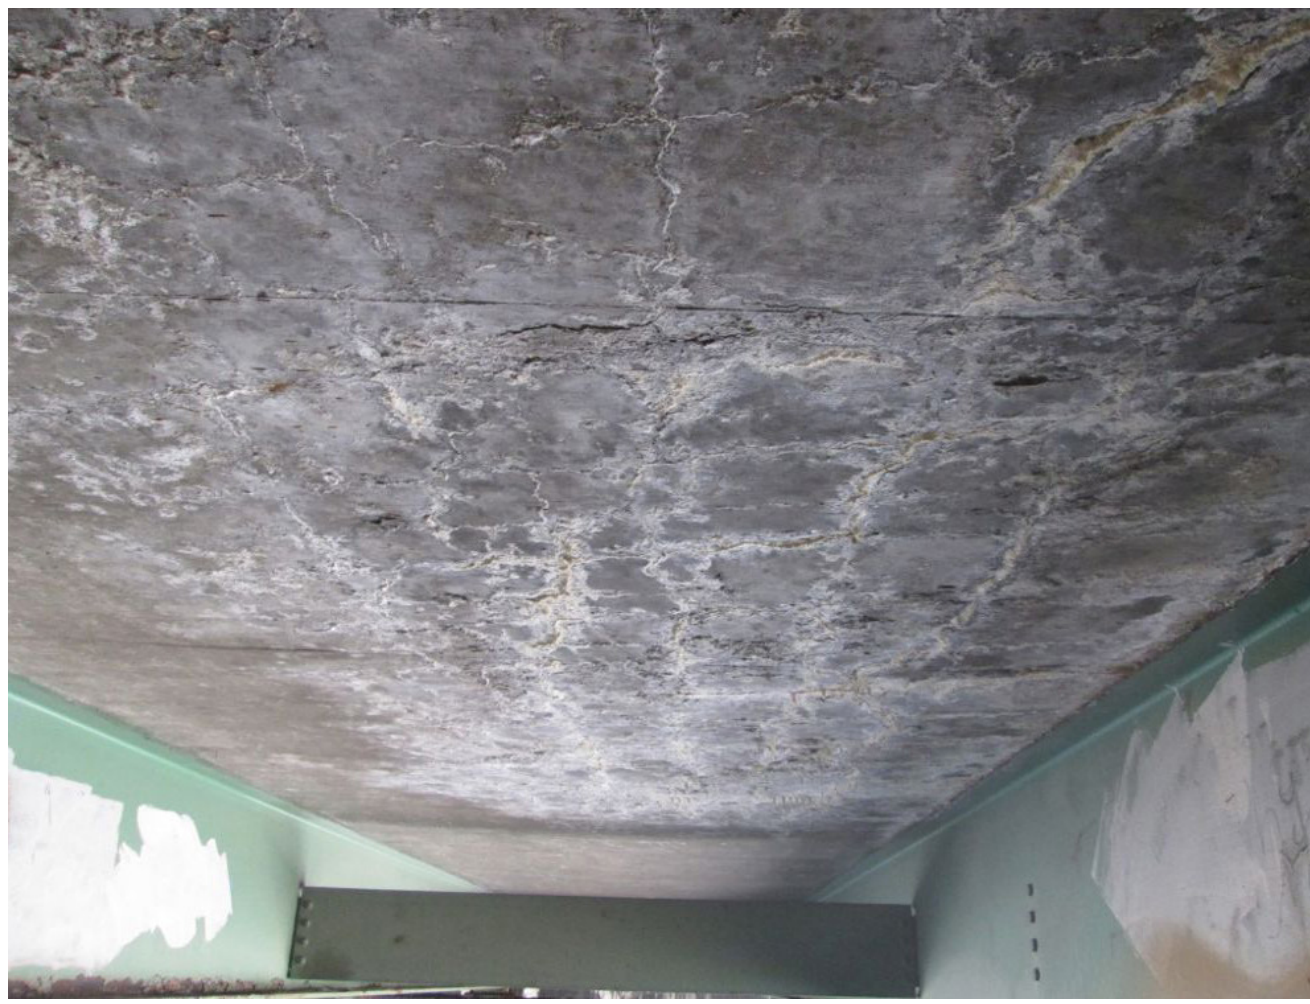
Spalling and Cracking Deck

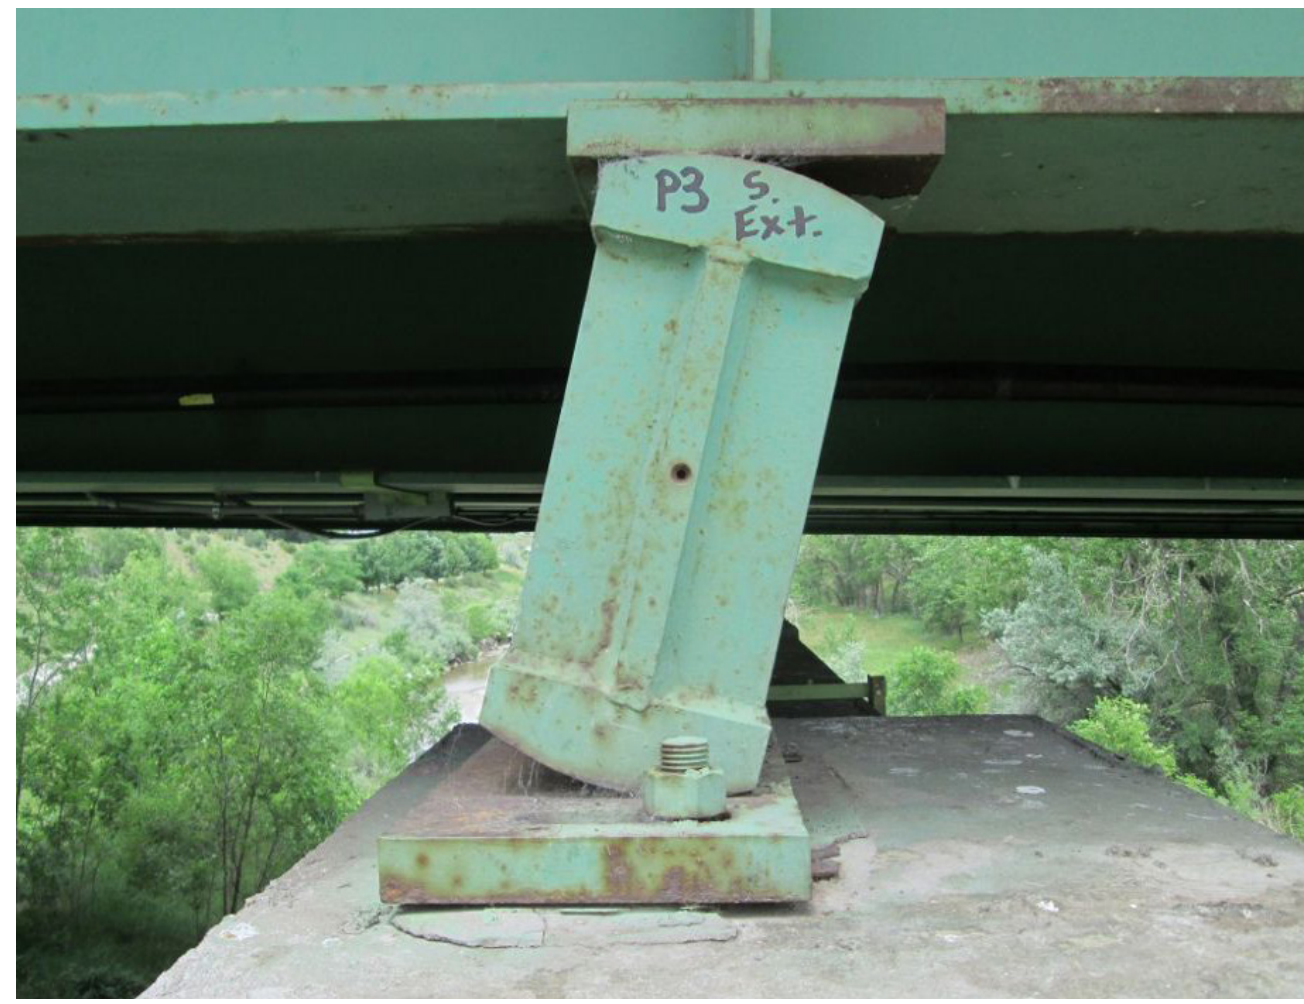
Tilted Girder Bearings Past Critical Angle

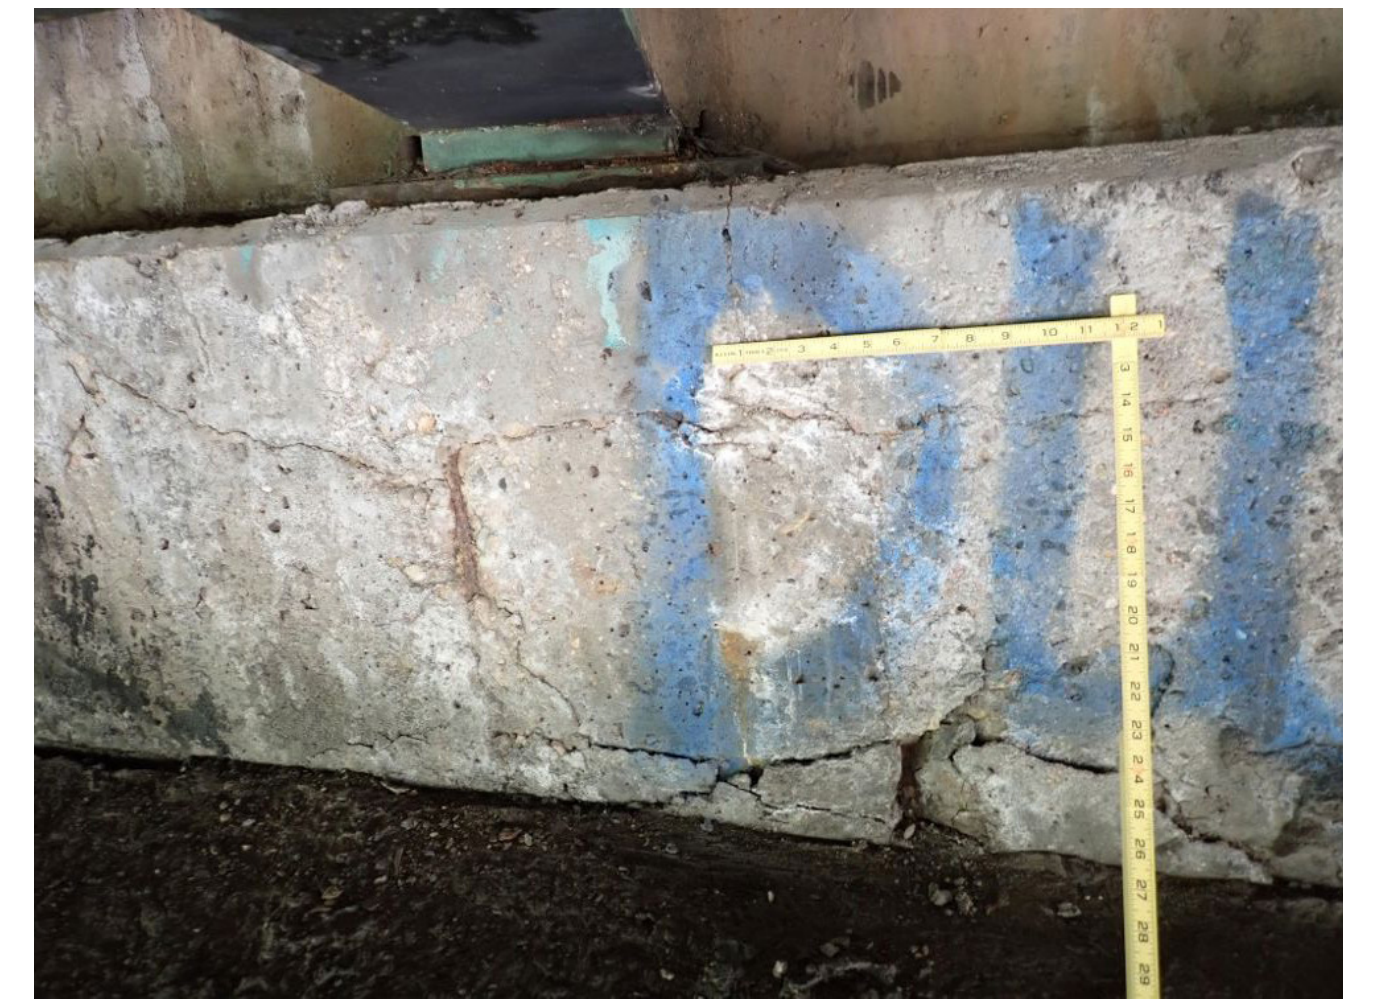
Cracked and Spalled Substructures

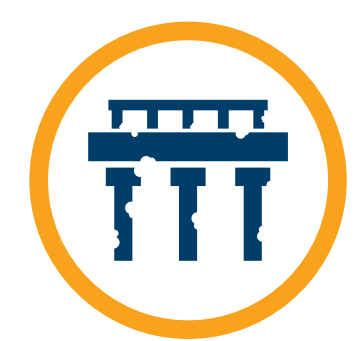
Corrosion and/or rust on superstructure

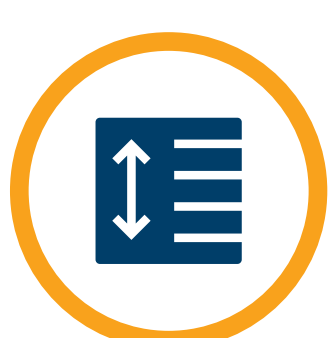
Substandard vertical clearance beneath bridge

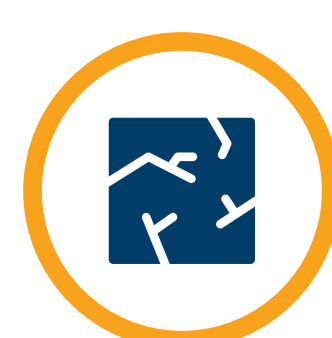
Cracking and spalling of deck underside

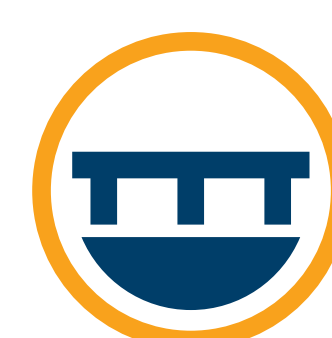
Substandard bridge railing

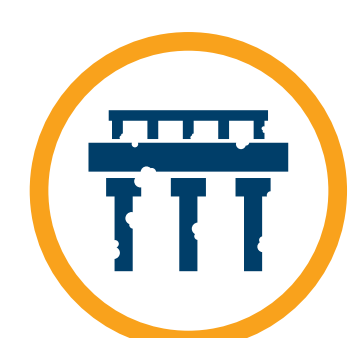
Corrosion and/or rust on superstructure

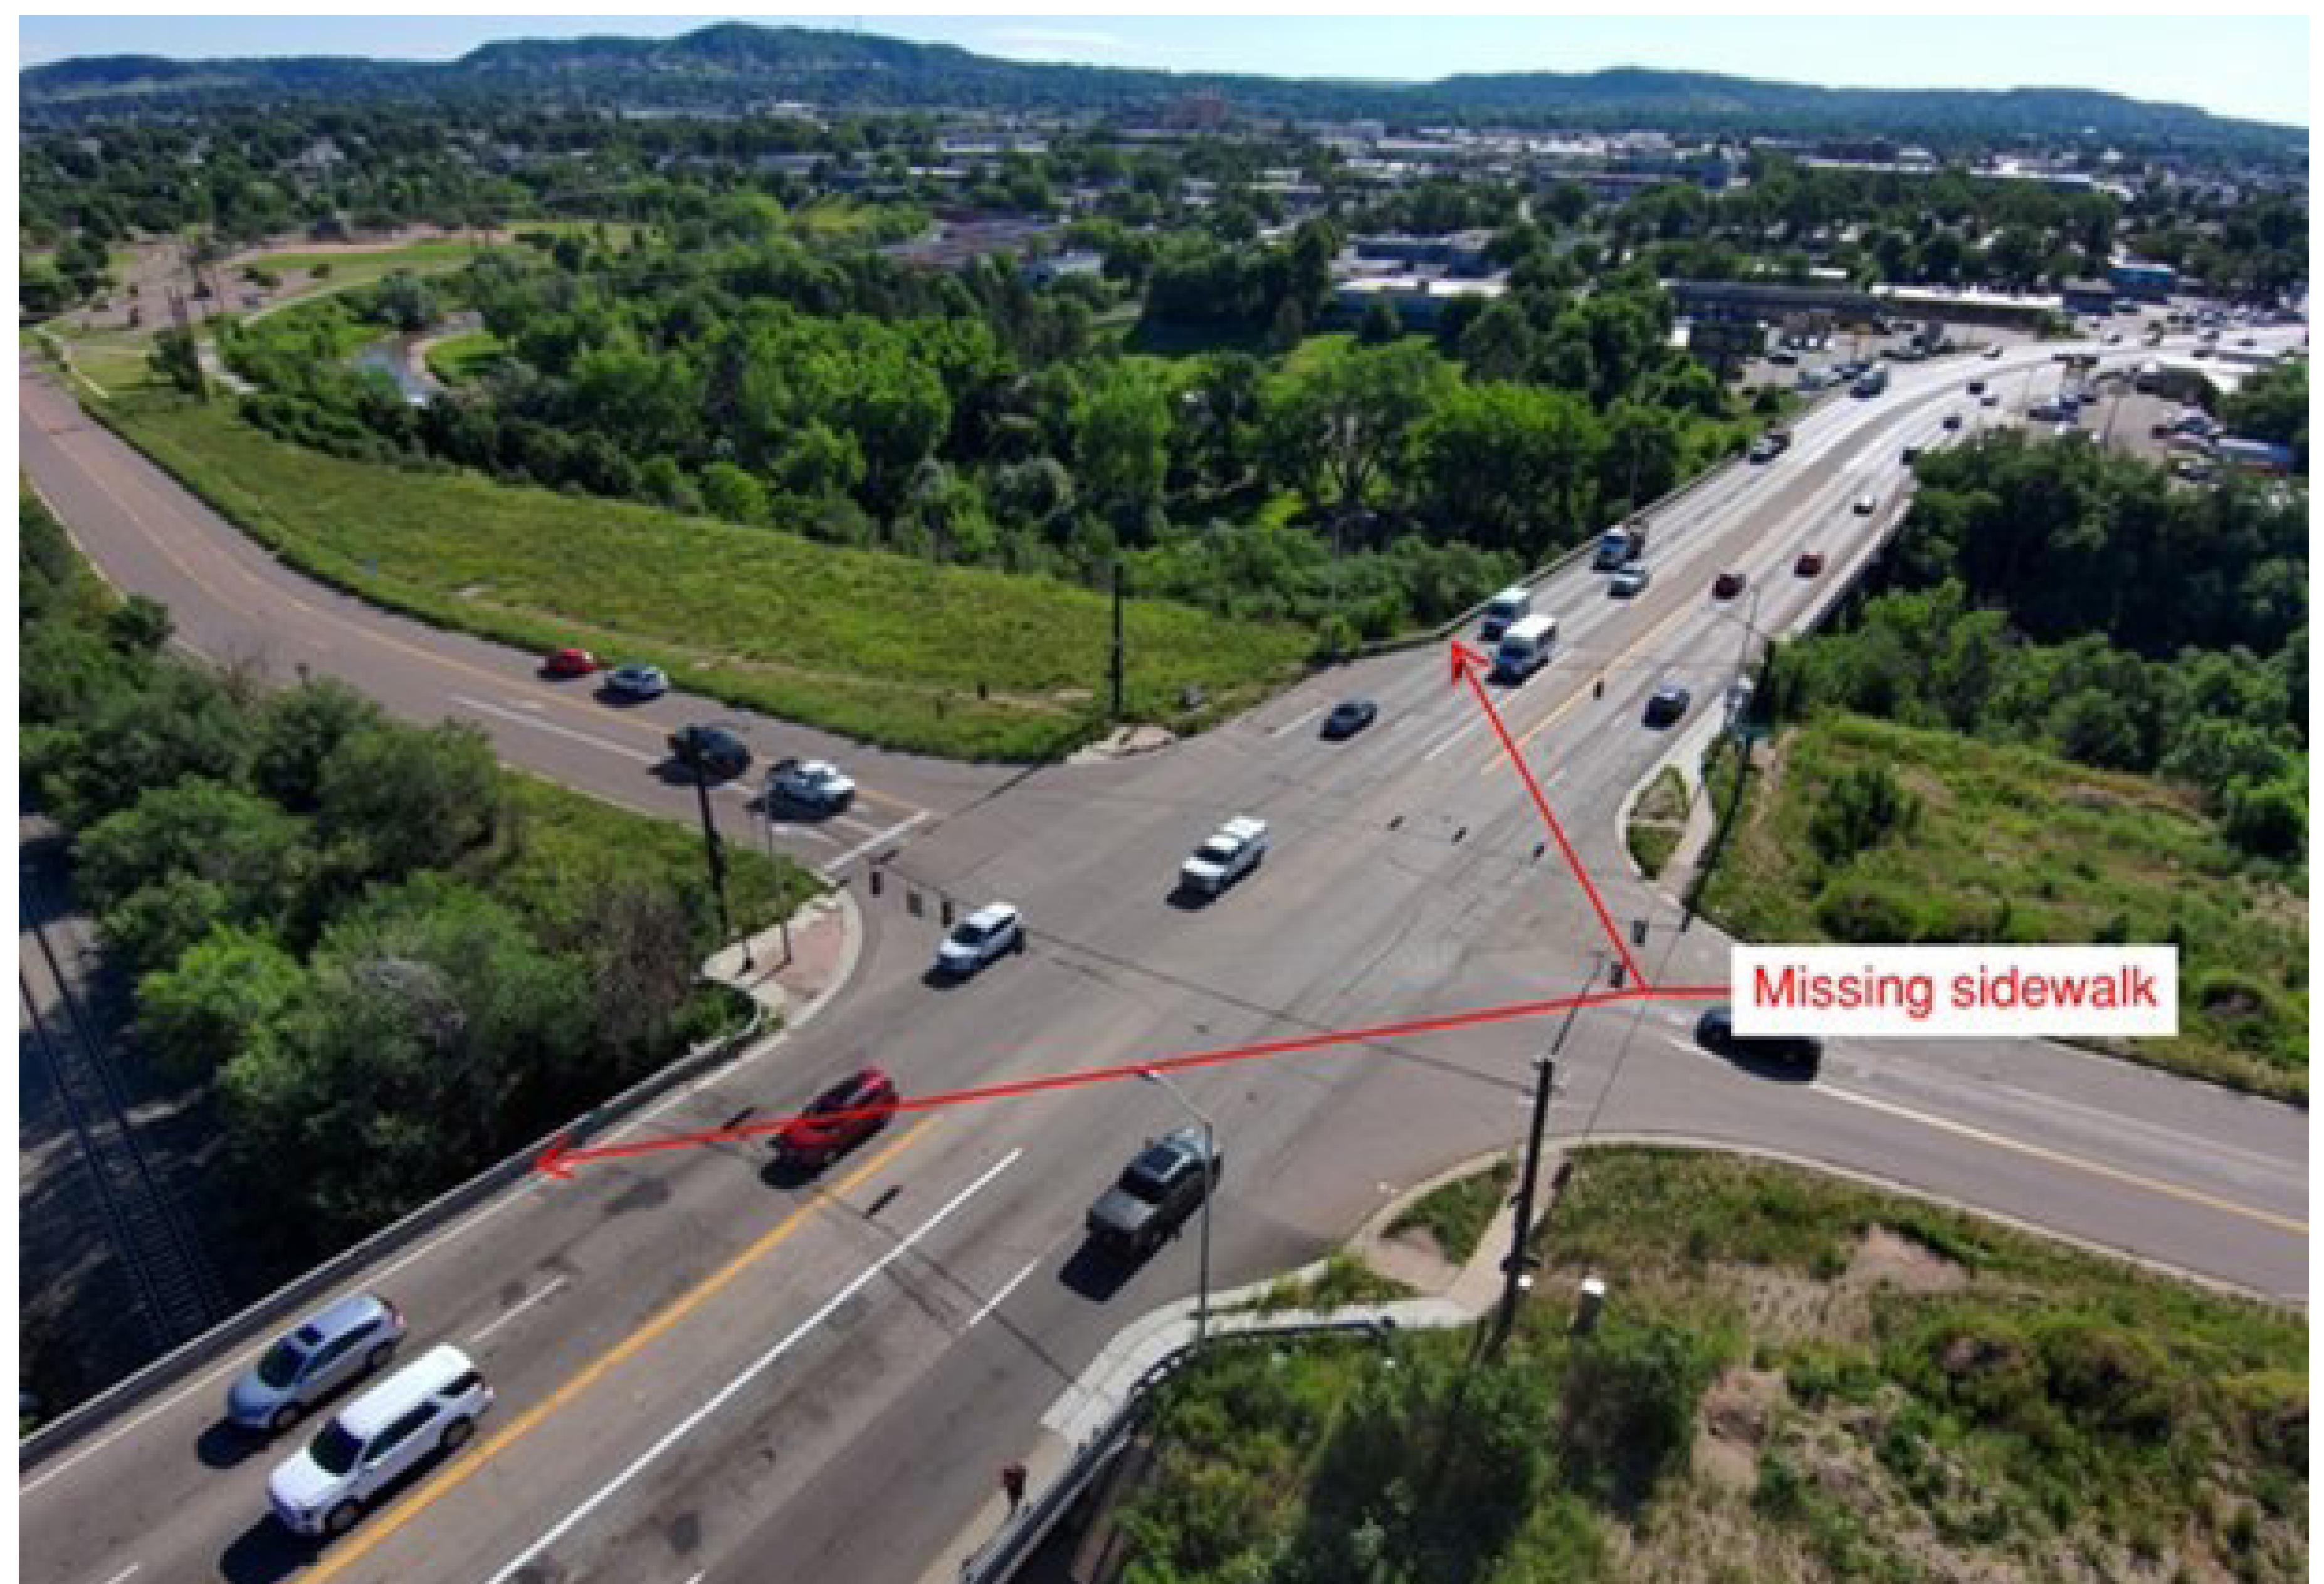
## MISSING SIDEWALK ALONG NORTH SIDE OF FILLMORE STREET

- Non-compliant sidewalk is provided along the south side of Fillmore Street, with no sidewalk present on the north side within the study limits.
- No connection from Fillmore Street to the Pikes Peak Greenway Trail currently exists.
- There are no bicycle facilities along Fillmore Street within the study limits.
